# **Safety Message**

## **Ames Arc Jet DC Power Supply Fire**

**Leadership VITS**  
September 18, 2006

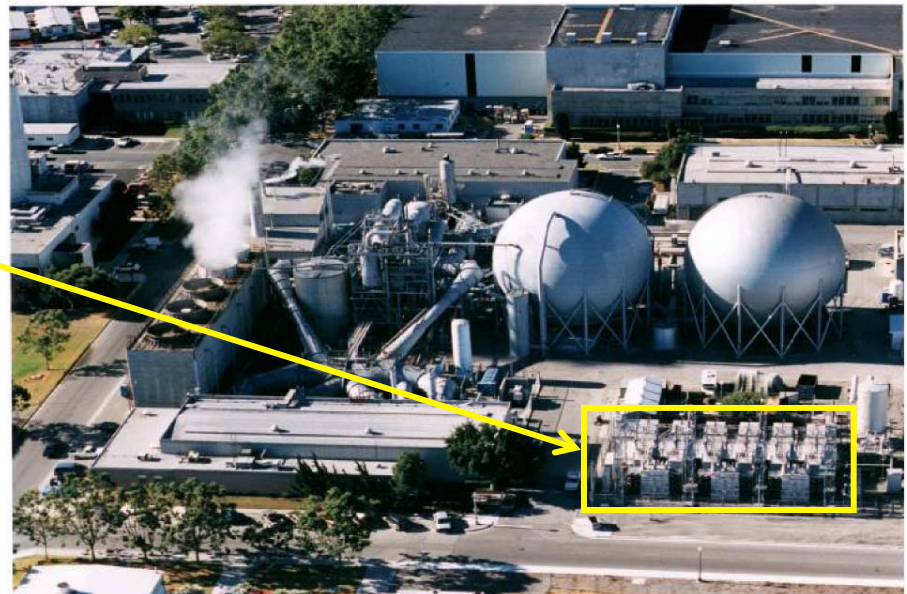
Arc Jet Complex

A 150 megawatt DC power supply and associated arc heater generates a high temperature, supersonic flow to simulate reentry conditions

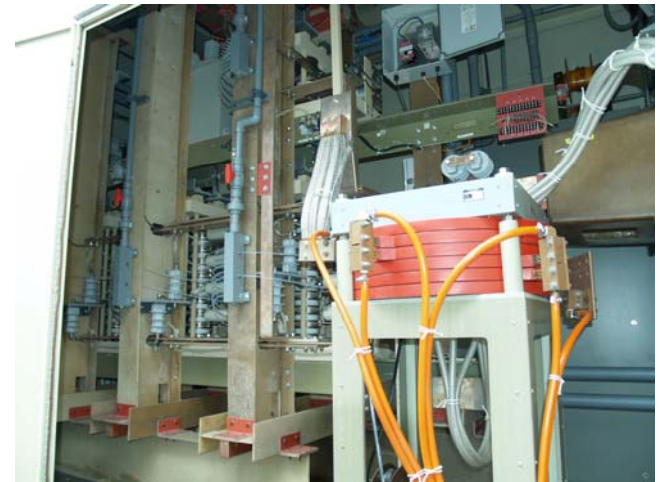
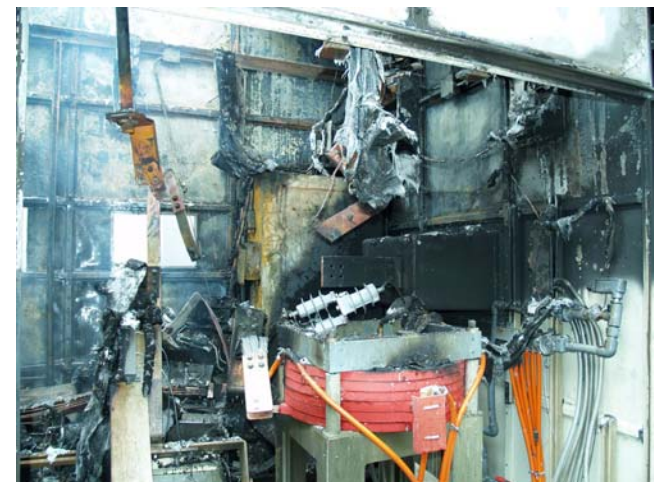
During Arc Jet operations a DC Power Supply Module was discovered burning

Internal components were severely damaged

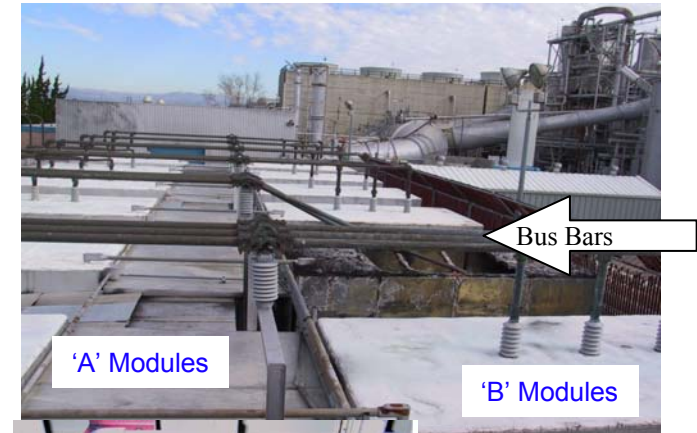
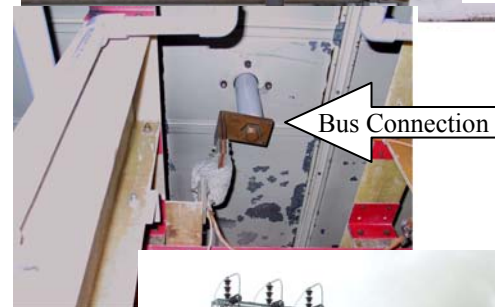
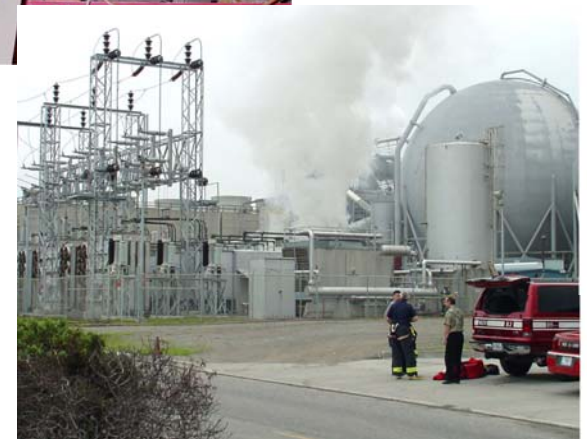
February 3, 2006: Module 2B cooling water turned off after a leak was detected

February 3, 2006, ~11:30 AM: Smoke was reported rising from the DC power modules
